Case No. CD223-003(RD)

Re: 338 S Fleming Ave, Dallas, TX 75203 (Tenth Street Historic District)

## **BRIEF IN OPPOSITION TO THE LANDMARK COMMISSION'S DECISION**

Project Name: Visual Foundation Evaluation Report

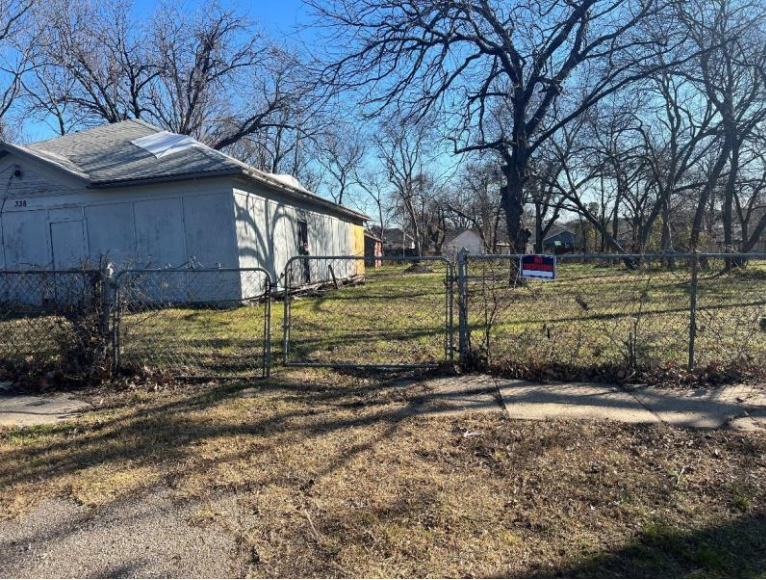
6593

The house is a "1-story" wood siding structure converted into residence with perimeter and interior piers and wood beam type foundation (see pic 6593). The structure appears to have collapsed. Most of the structure is sitting directly on the ground (see pics 6596, 6610 and 6612). Crawl space was not accessible, and any visible members of the foundation were rotten (see pics 6598, 6599 and 6602). None of foundation members are salvageable. The siding, walls and ceiling are in deteriorating condition and contain visible cracks. The walls are made/covered by siding, plywood, and sheet metal (see pics 6603, 6607 and 6608). The walls have large openings to the outside (see pic 6609). Most of the house structural lumber is damaged and not salvageable. Any attempt to lift this structure to repair the foundation might result in total collapse of the building. Our findings are similar to structural report obtained by the owner.

1. A total reconstruction of the foundation will be needed if this building can be raised.
2. There is limited amount of material that could be salvaged.

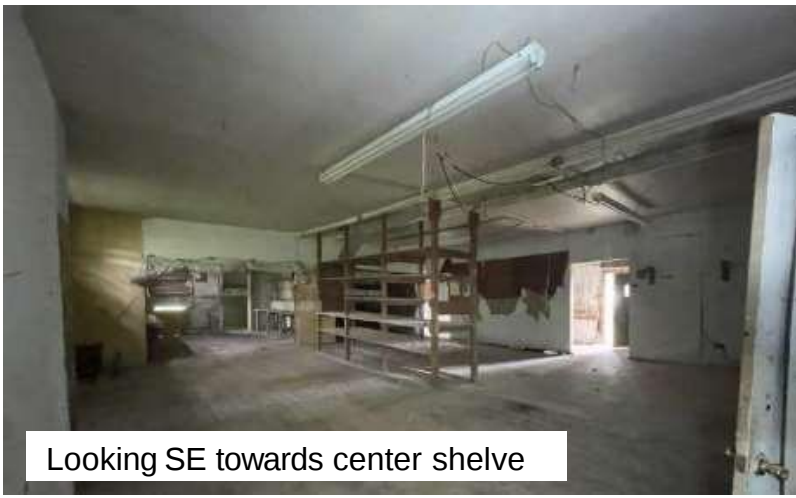
Looking SE towards center shelf

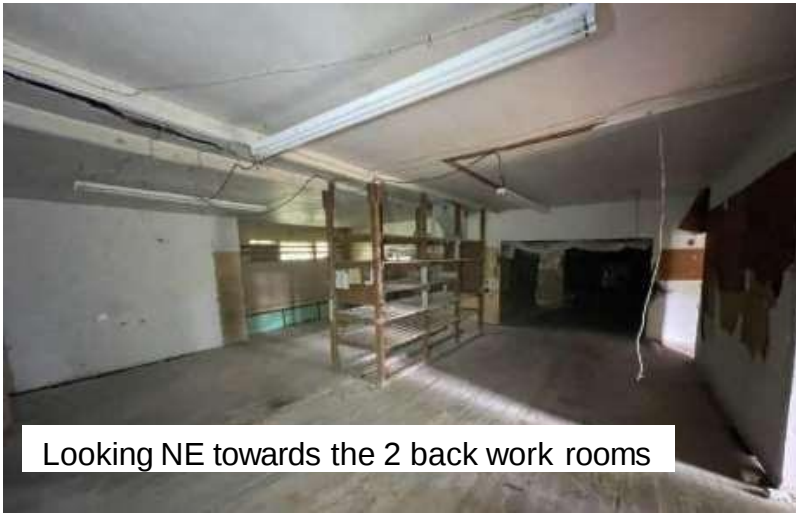
Looking NE towards the 2 back work rooms

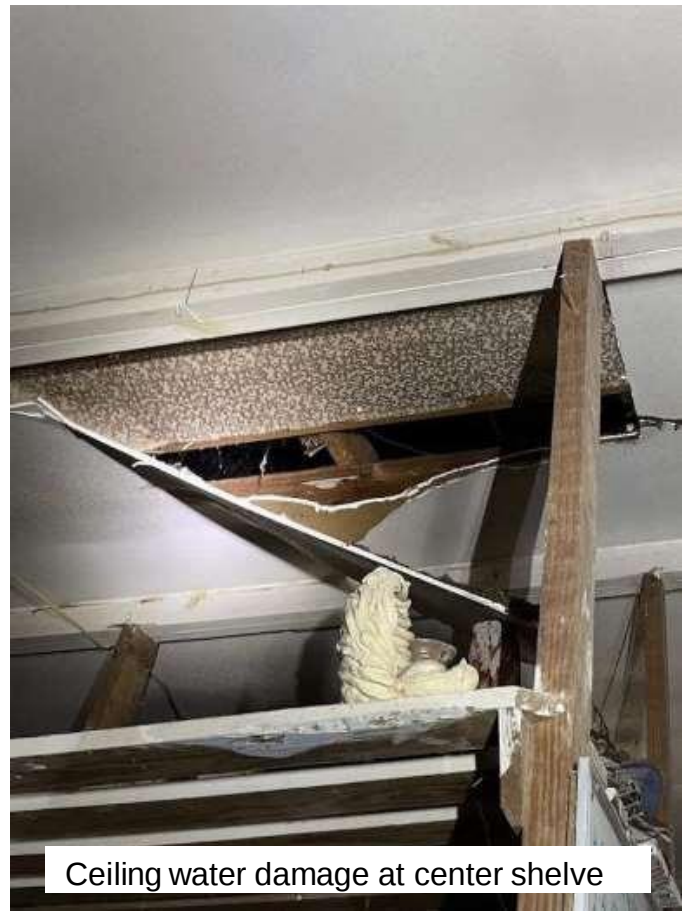
Ceiling water damage at center shelf
