Re: 338 S Fleming Ave, Dallas, TX 75203 (Tenth Street Historic District)

## **BRIEF IN OPPOSITION TO THE LANDMARK COMMISSION'S DECISION**

Project Name: Visual Foundation Evaluation Report

### **General Structural Initial Foundation Inspection**

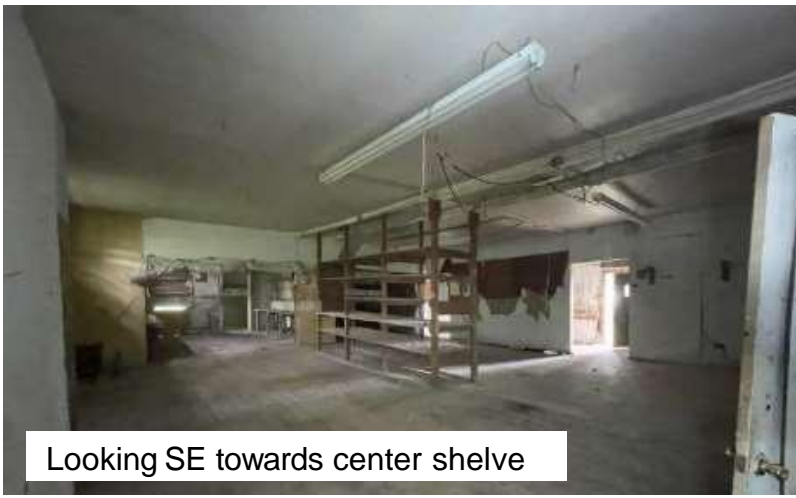
Looking SE towards center shelf

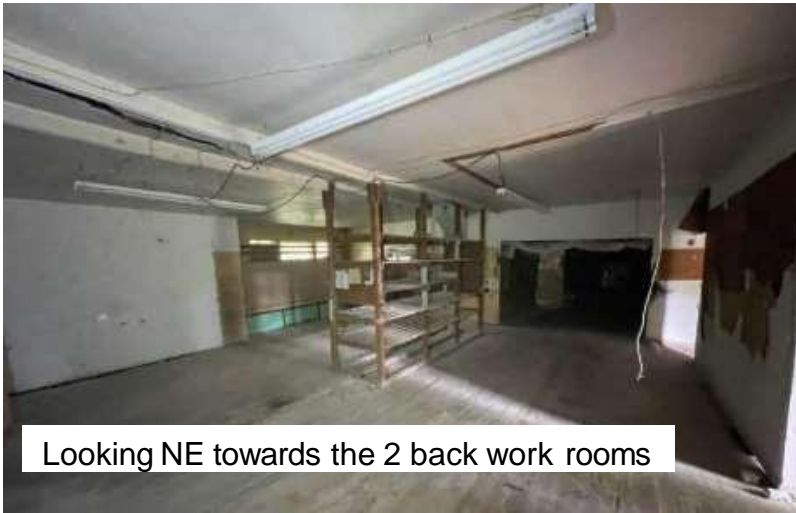
Looking NE towards the 2 back work rooms

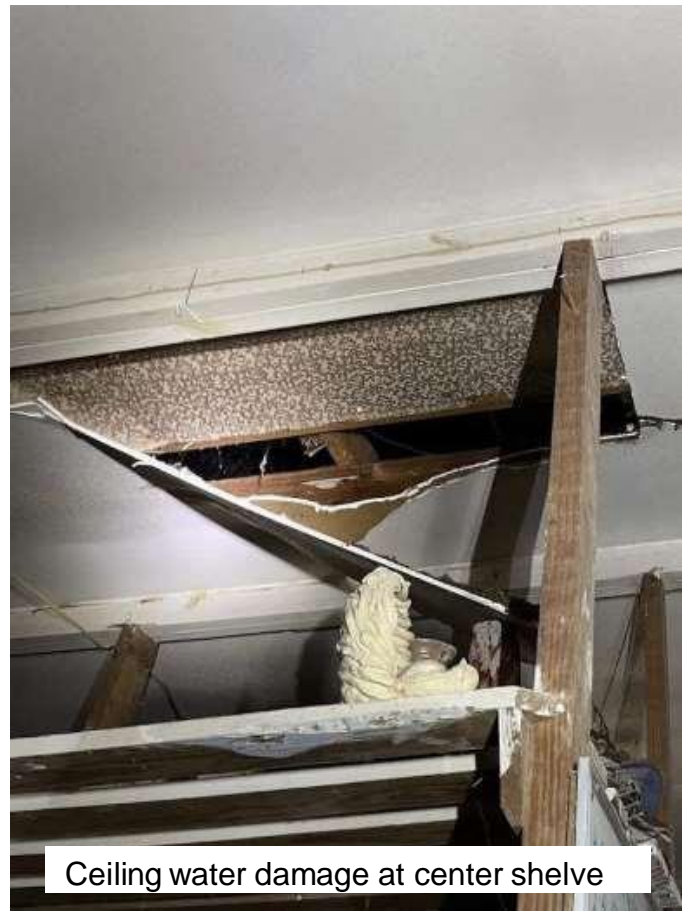
Ceiling water damage at center shelf
