**LANDMARK COMMISSION****AUGUST 3, 2026**

FILE NUMBER: COA-26-000338  
LOCATION: 2615 Park Row Ave.  
STRUCTURE: Noncontributing  
COUNCIL DISTRICT: 7  
ZONING: PD-595

A request for an extension of a previously-approved Certificate of Demolition for the main structure (Standard: Imminent Threat to Public Health or Safety).

RE: 2615 Park Row Dr.  
Dallas, TX  
Structural Evaluation

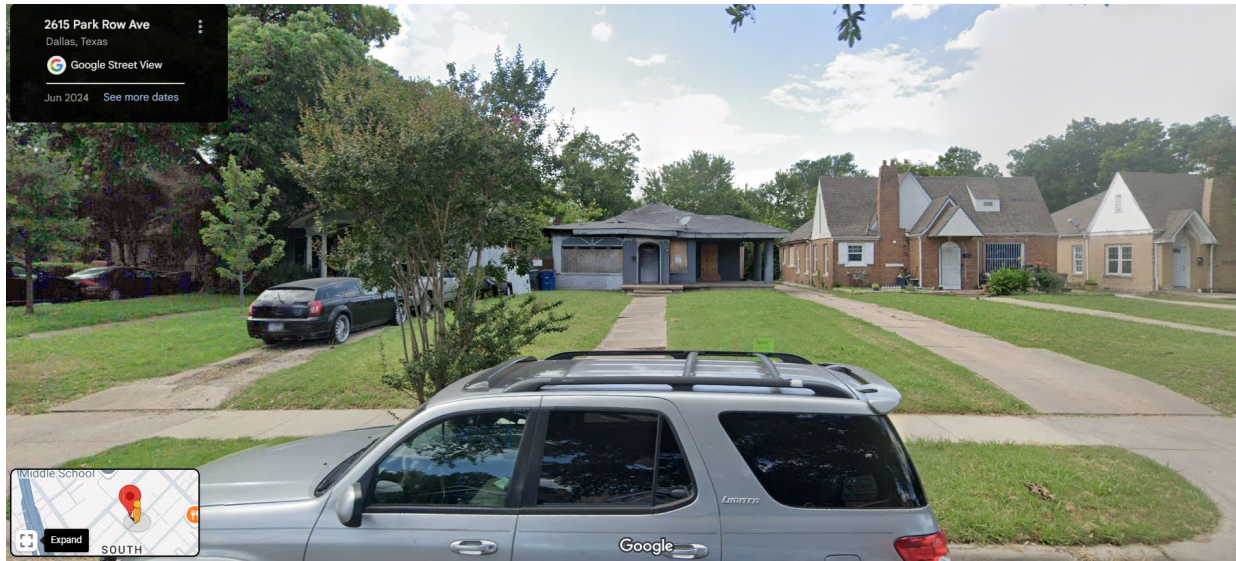
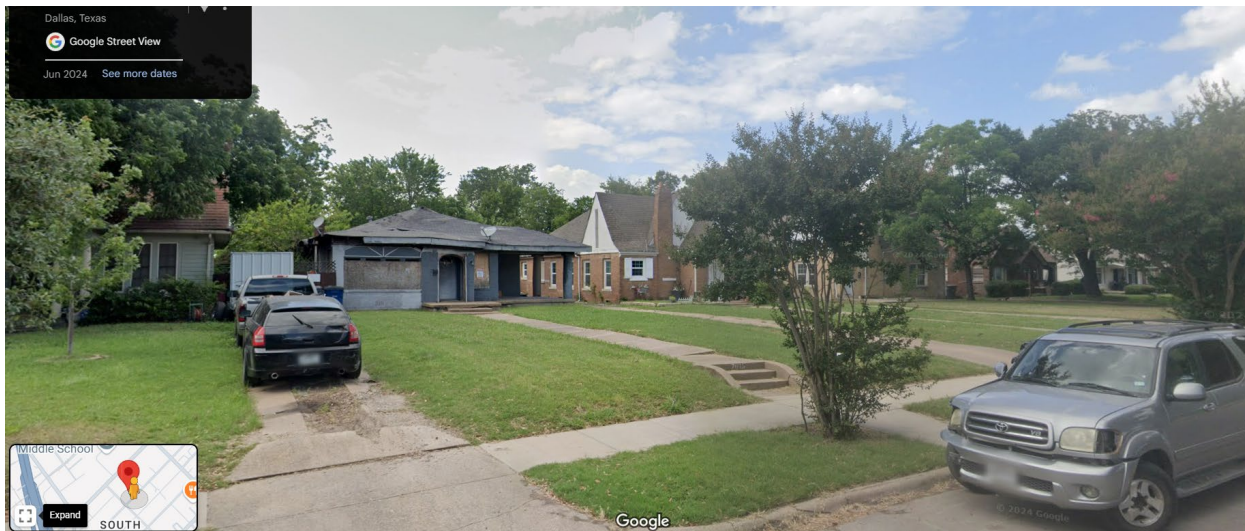
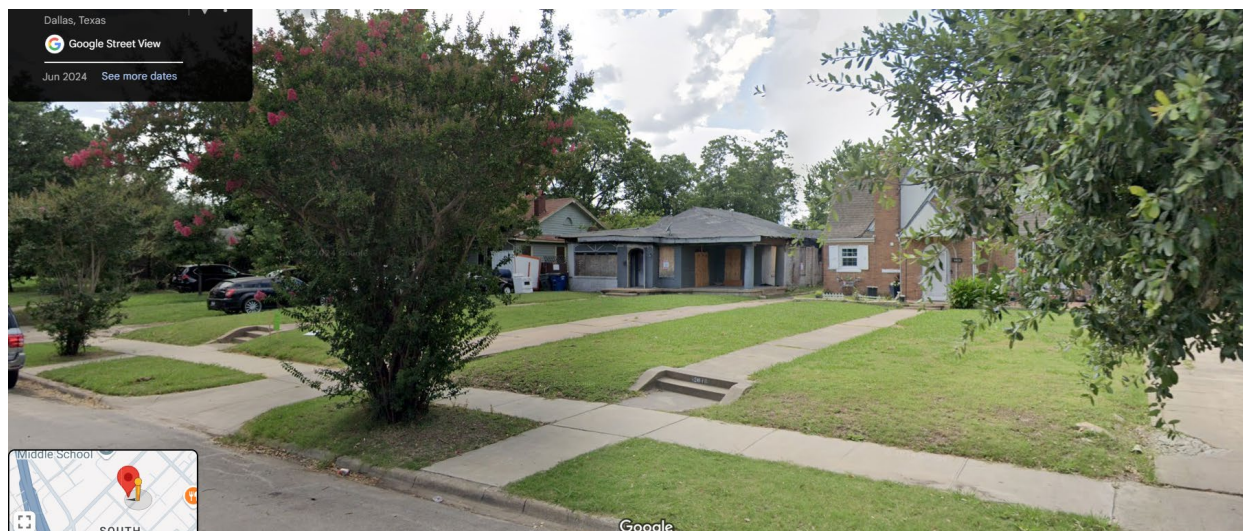
2615 Park Row Ave.

The structure has seen significant deterioration as well as a fire that caused extensive damage and structural sagging in the roof.

That the request for an extension of a previously-approved Certificate of Demolition for the main structure (Standard: Imminent Threat to Public Health or Safety) be **approved** with the findings of fact that the request for demolition was previously approved on July 15, 2025, that the structure constitutes a documented major and imminent threat to public health and safety, that the demolition or removal is required to alleviate the threat to public health and safety, that there is no reasonable way, other than demolition or removal to eliminate the threat in a timely manner, and that the structure is **noncontributing** to the district due to alterations that have affected its historic integrity. The proposed demolition, therefore, meets the standards in City Code Section 51A-4.501(h)(4)(C).

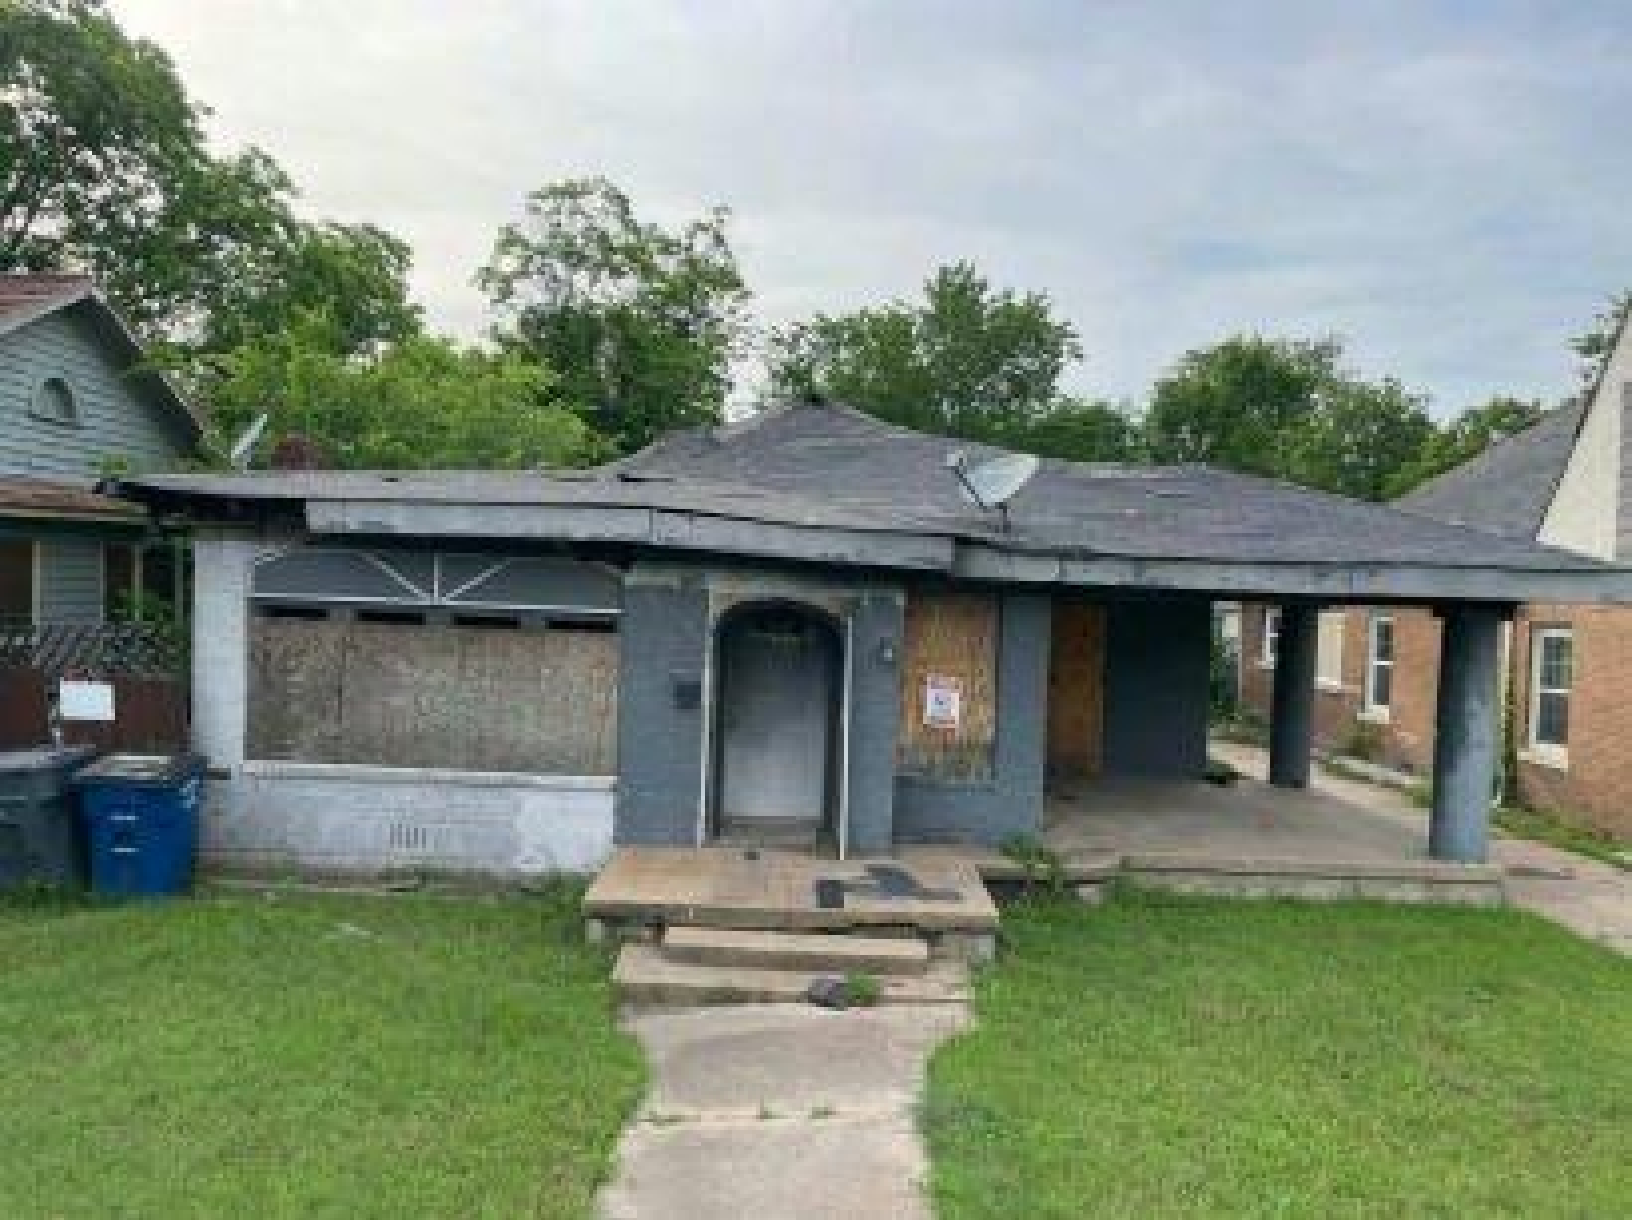
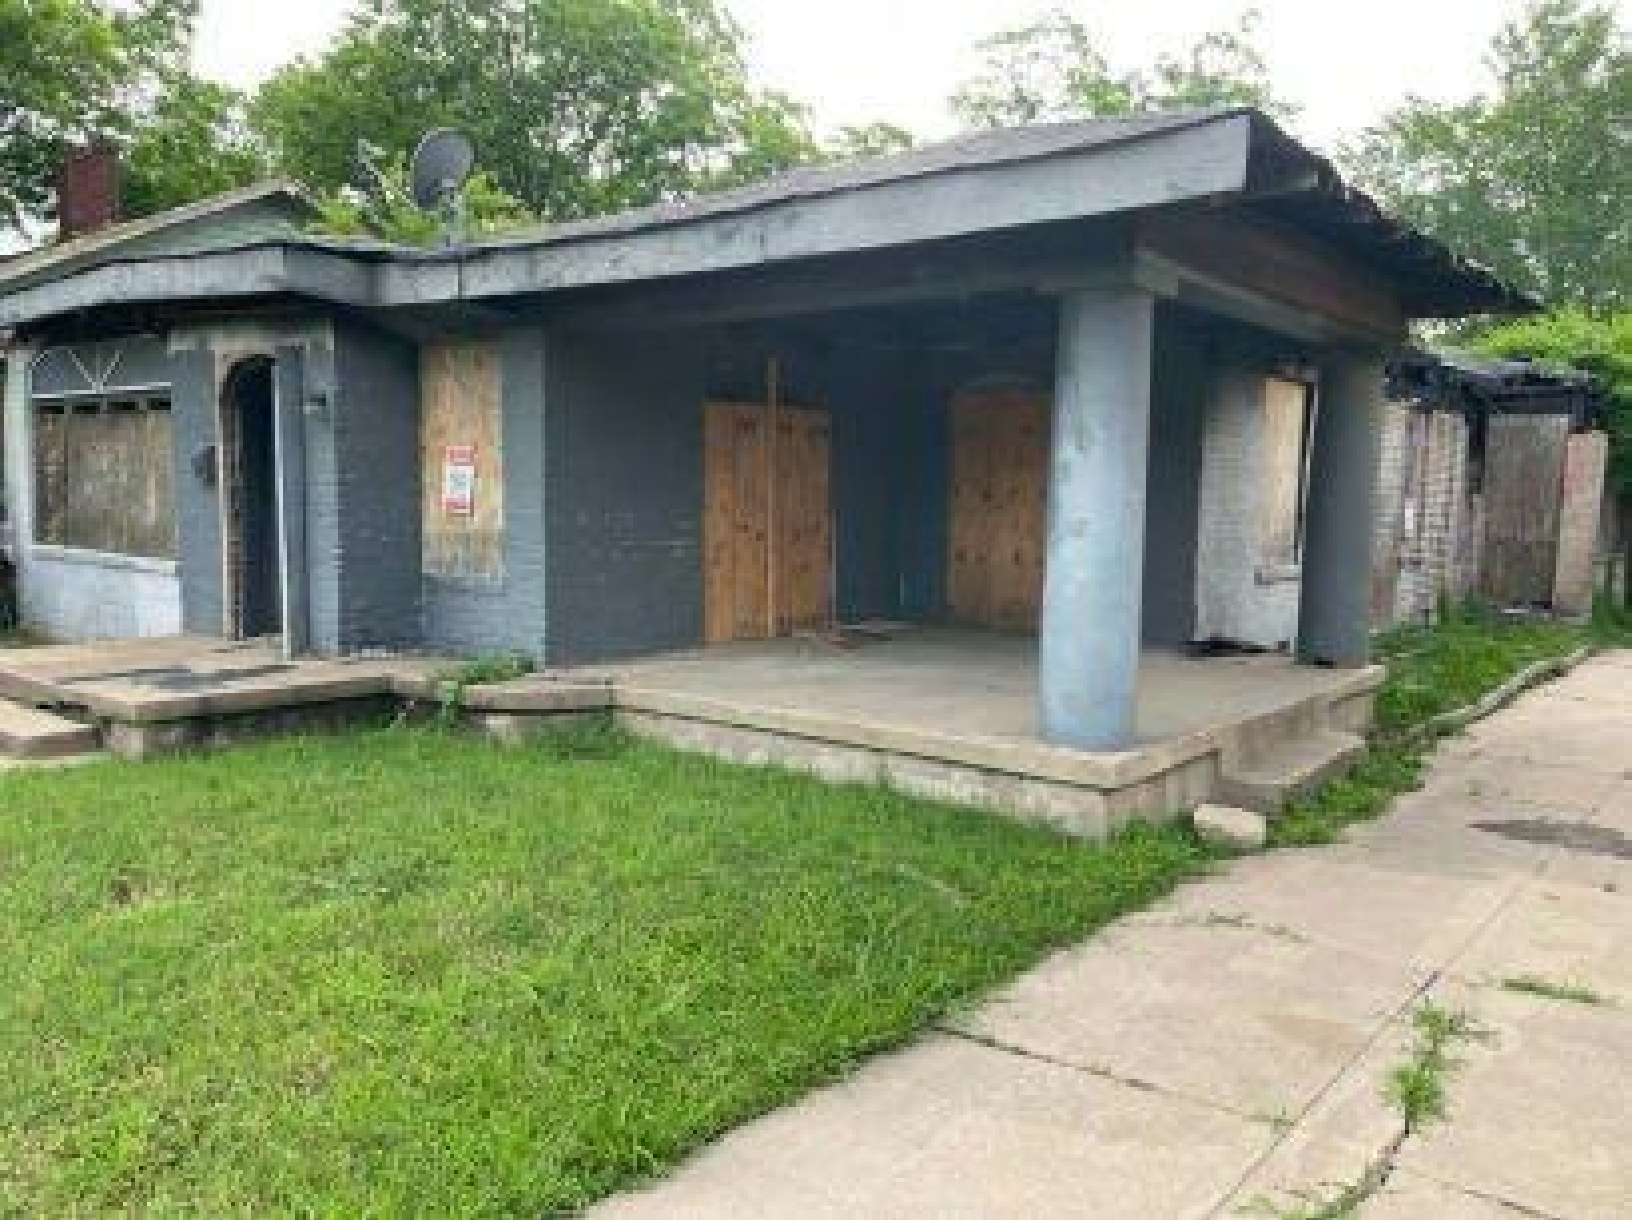
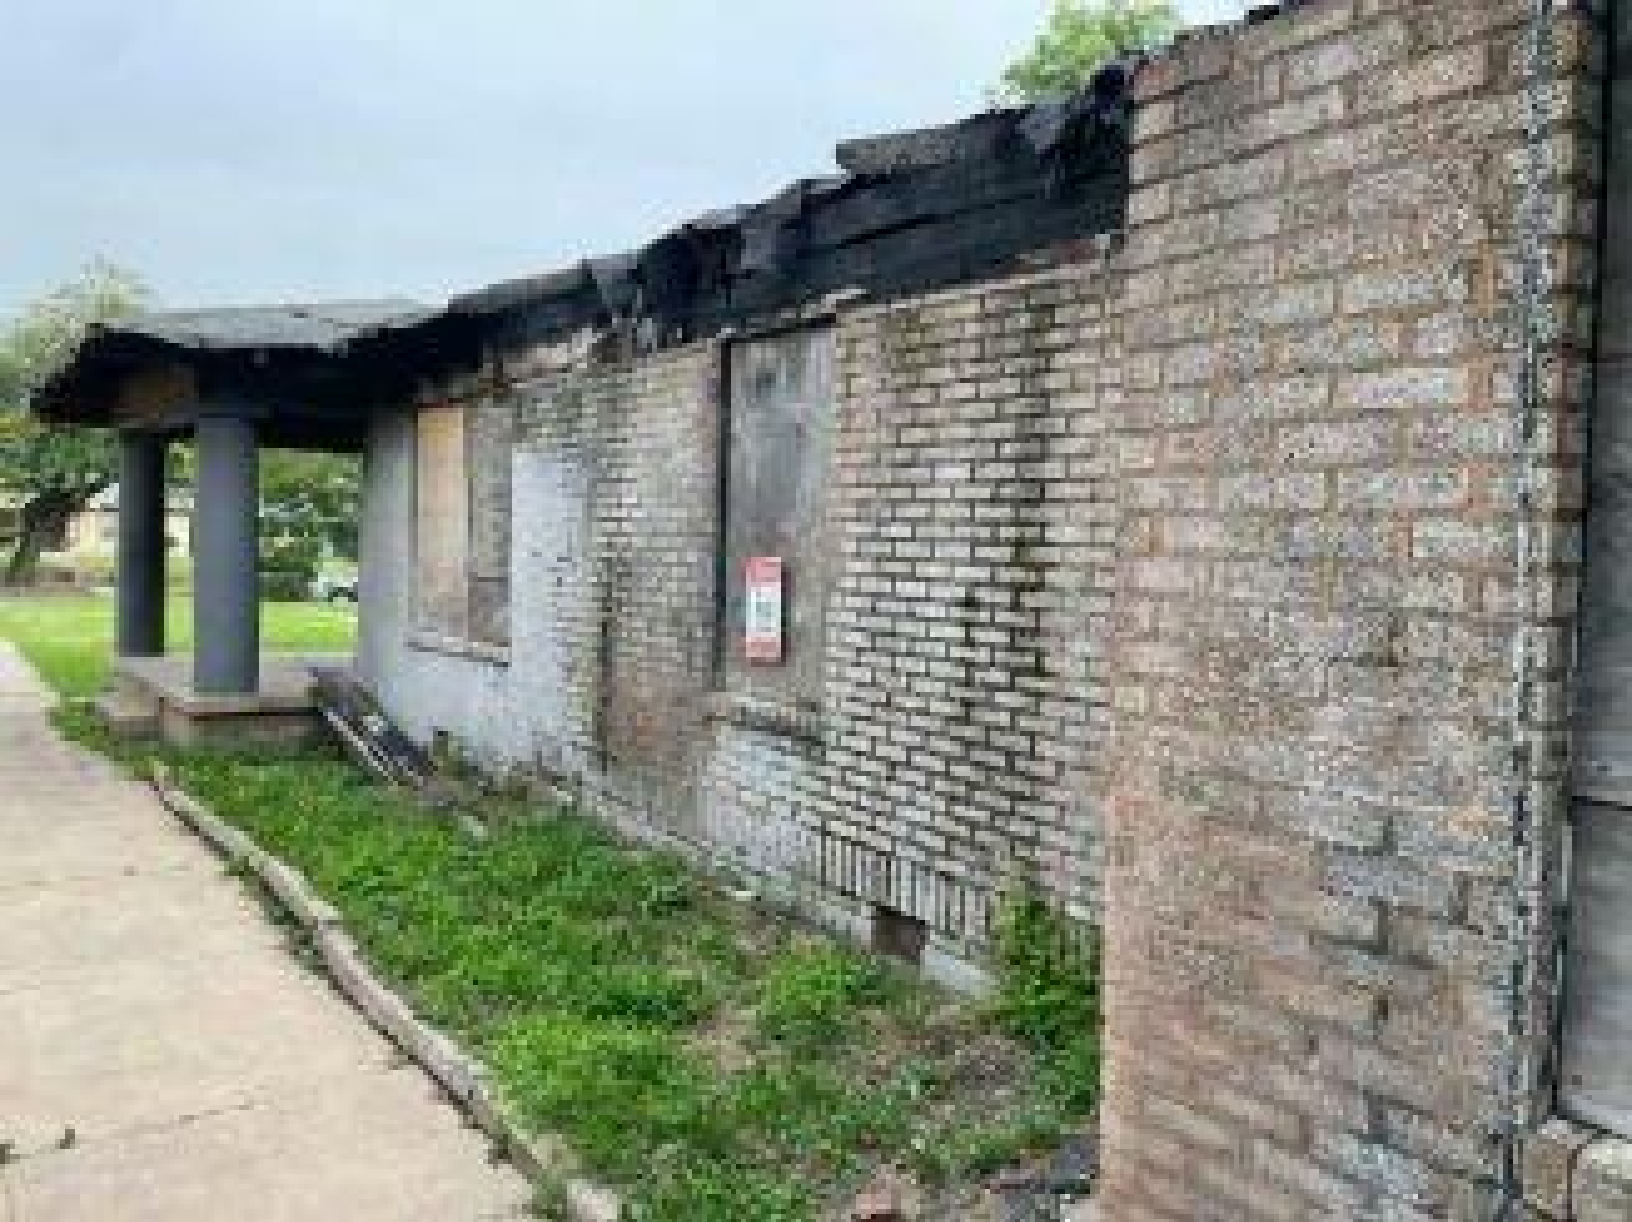
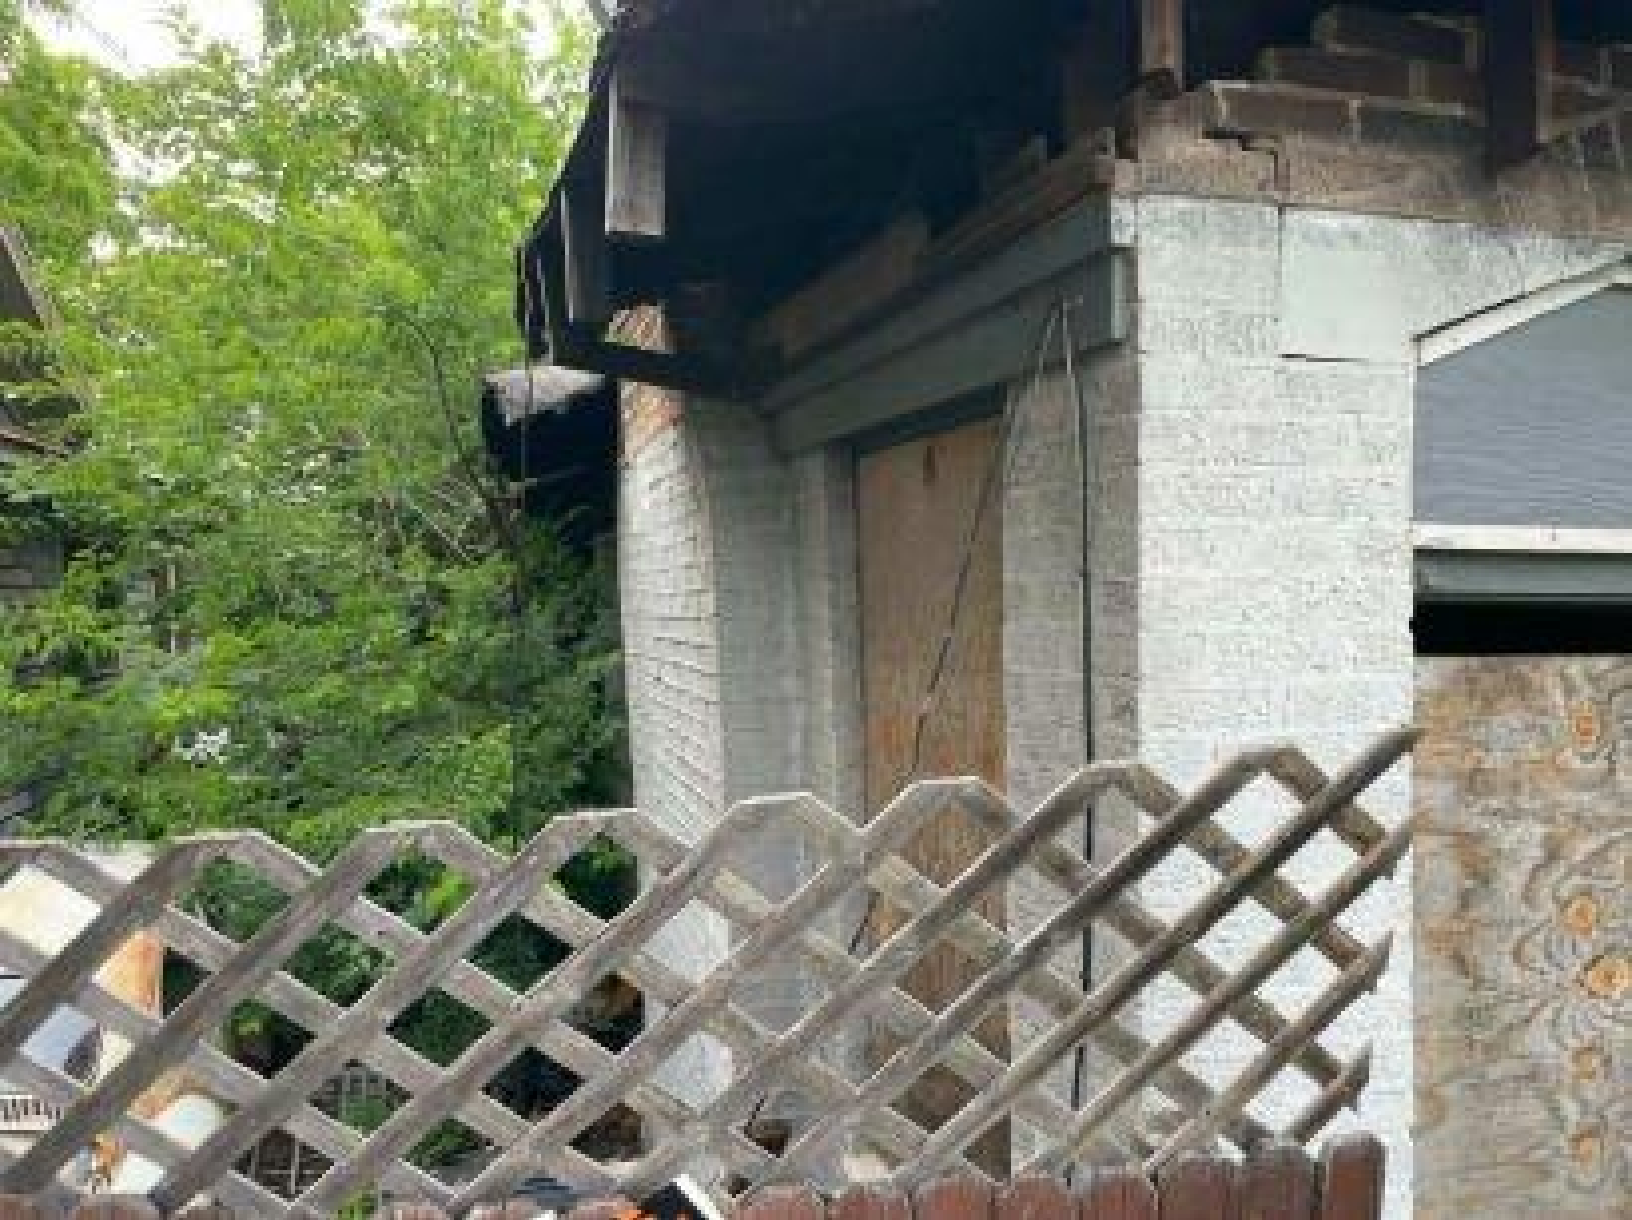
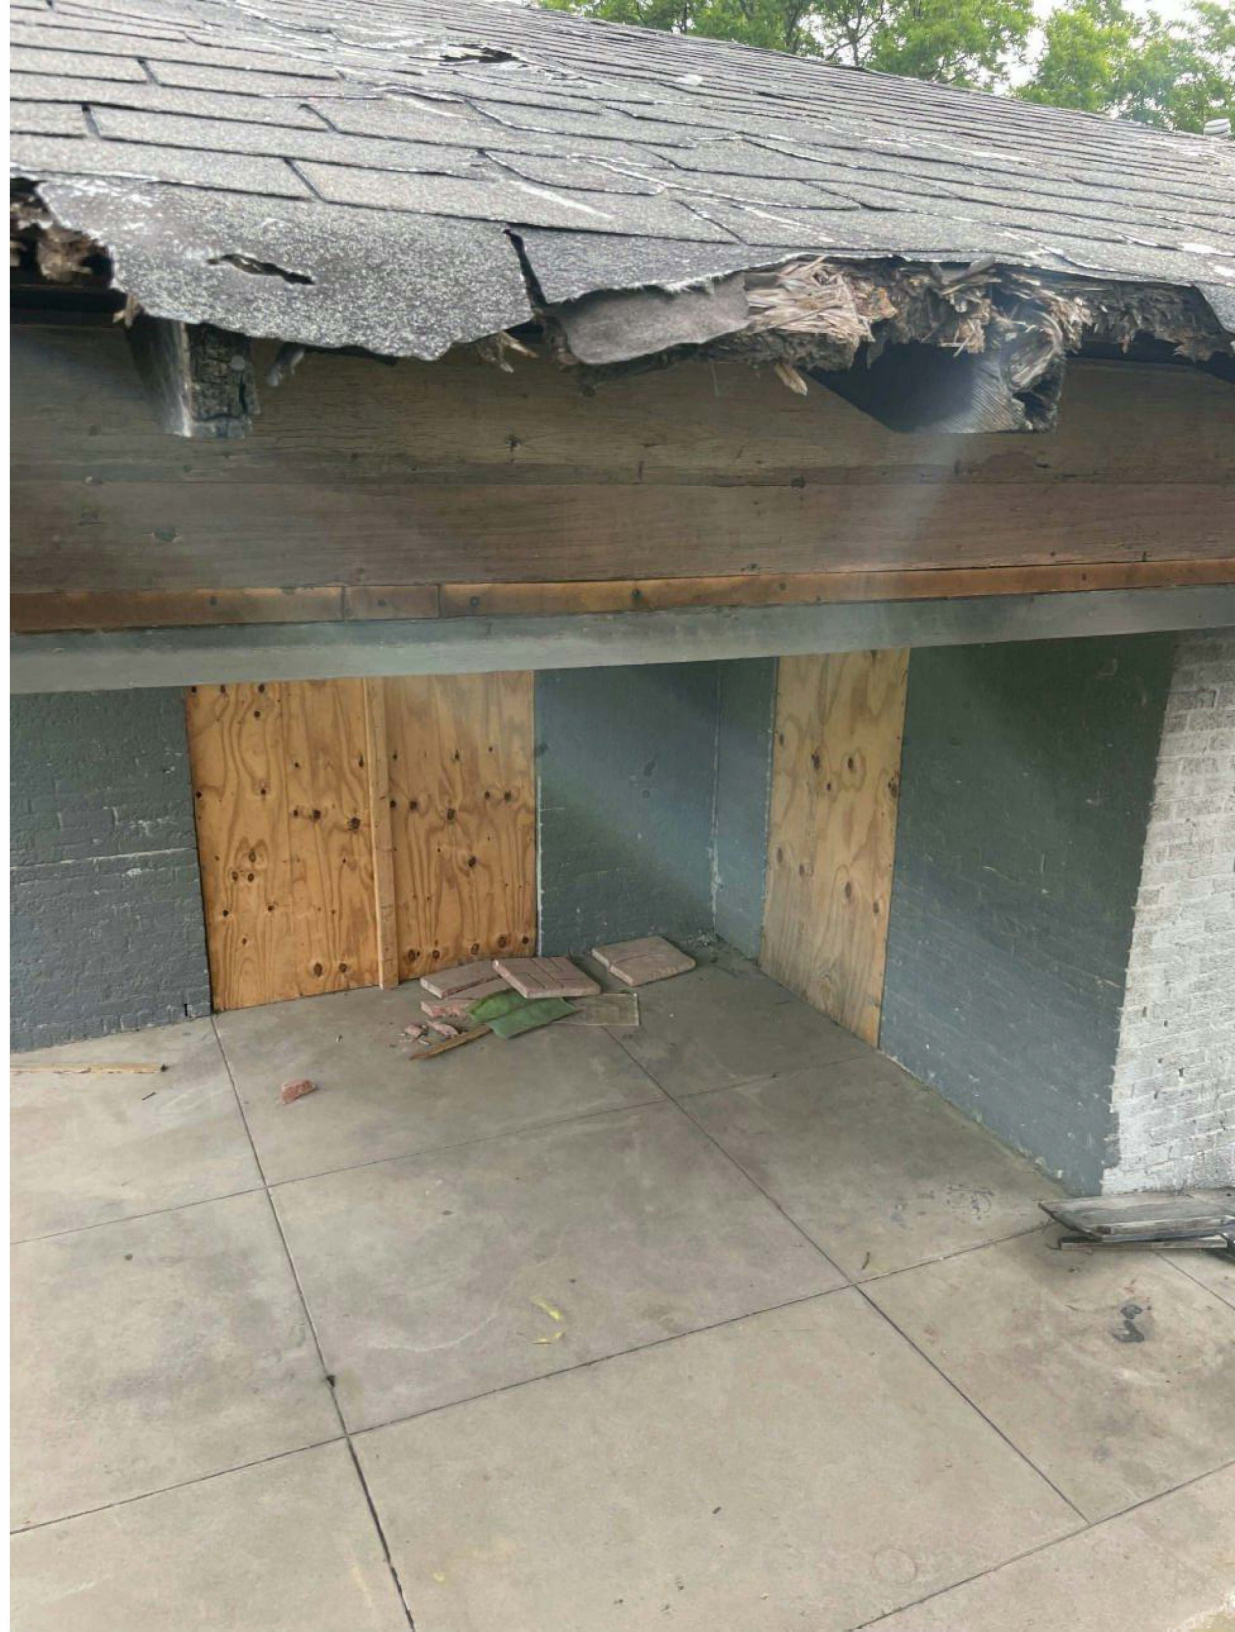
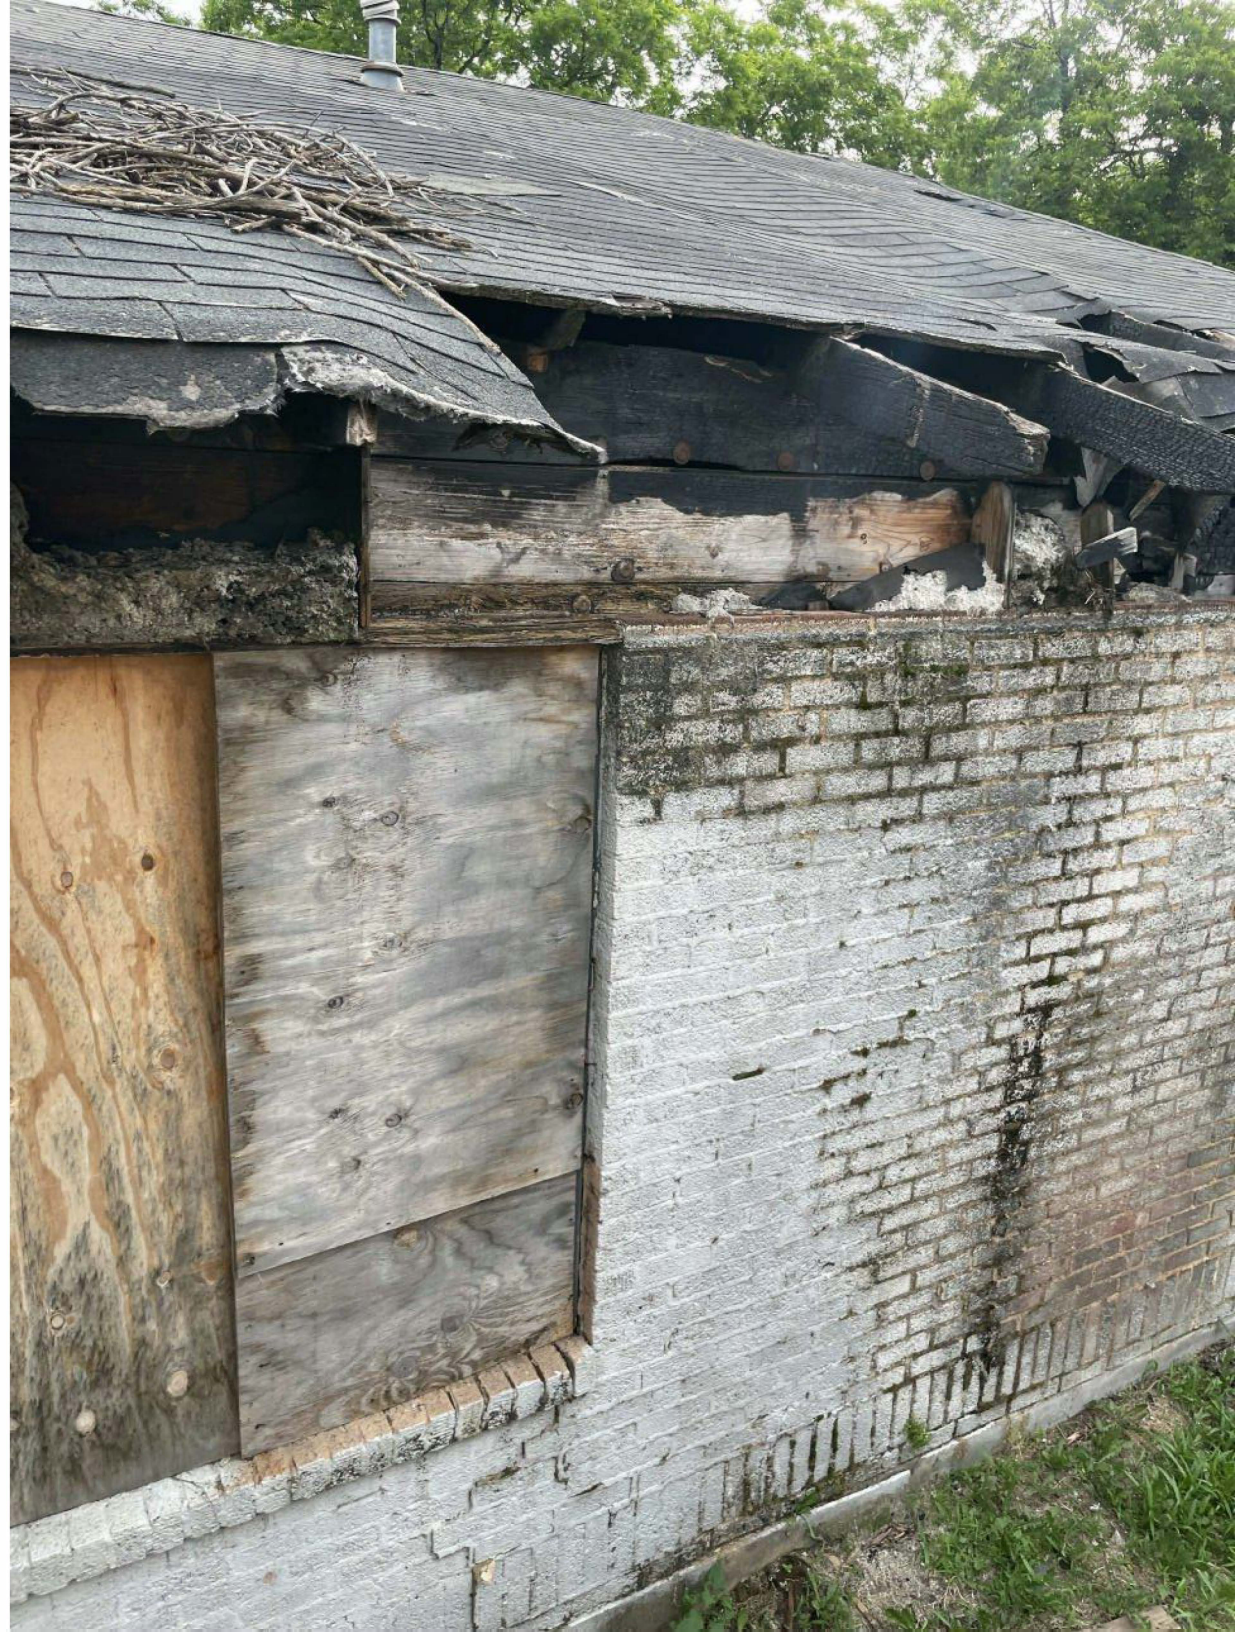
Per our review the structure is a single story, wood-framed structure with brick veneer over pier and beam foundation system.

The wood framing of the entire structure will need to be replaced due to the fire and subsequent exposure to the elements. There are temporary supports in place for the masonry arches to prevent collapse and the foundation is in very poor shape. We would not recommend re-building on the existing foundation.

In summary, we would not recommend repairing this structure as performance would be very poor and thus recommend it be scraped and building a new structure on the site as needed.

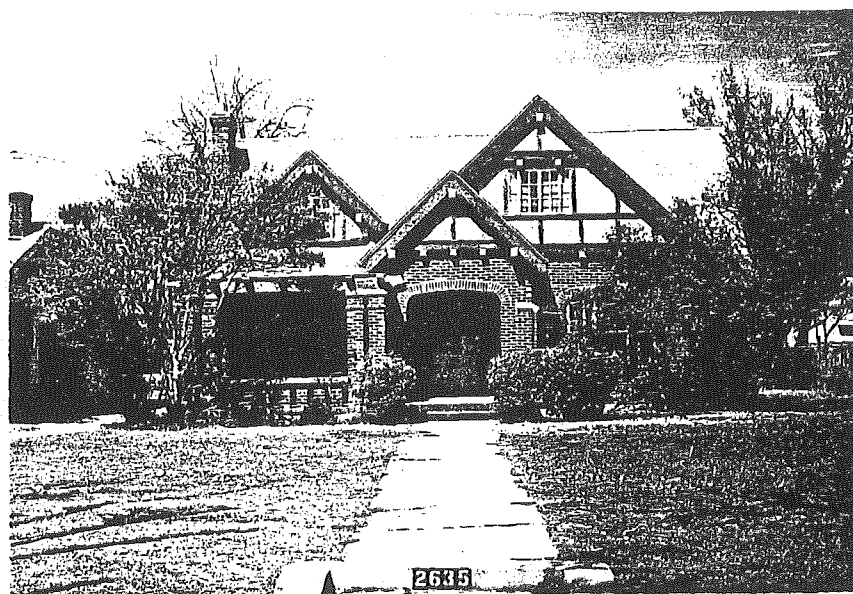
2635 Park Row

Jacob Winterman, 7-Room, \$8,000  
 Rough, Red Brick; Stucco, Half Timbers  
 Builders Investment Company, Contractor

The use of space behind dormers and gables as living space make this a semi-bungalow or bungaloid residence. Jacobethan elements such as prominent front gables and dormers with stucco and half-timbering, large exposed wood beams, chimney pots, arches, and small buttresses make this one of the most extensively detailed houses on Park Row. This is the first of several Builders Investment Company houses trimmed with Jacobethan elements.
