Case No. CD223-003(RD)

Re: 338 S Fleming Ave, Dallas, TX 75203 (Tenth Street Historic District)

## **BRIEF IN OPPOSITION TO THE LANDMARK COMMISSION'S DECISION**

Project Name: Visual Foundation Evaluation Report

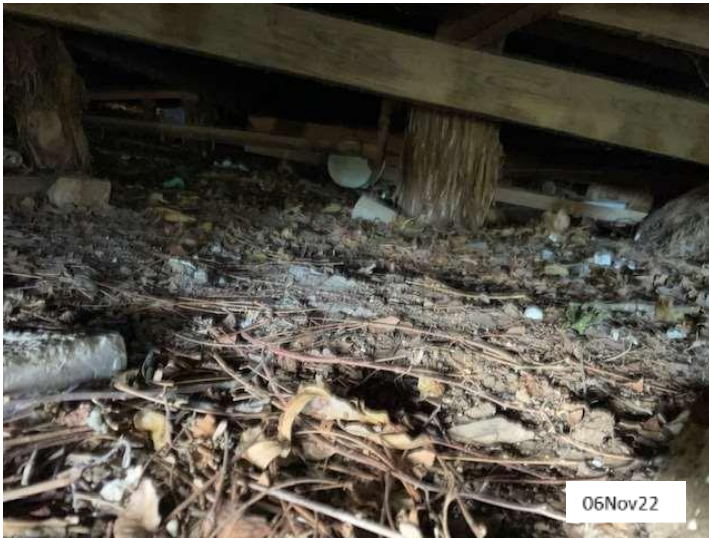
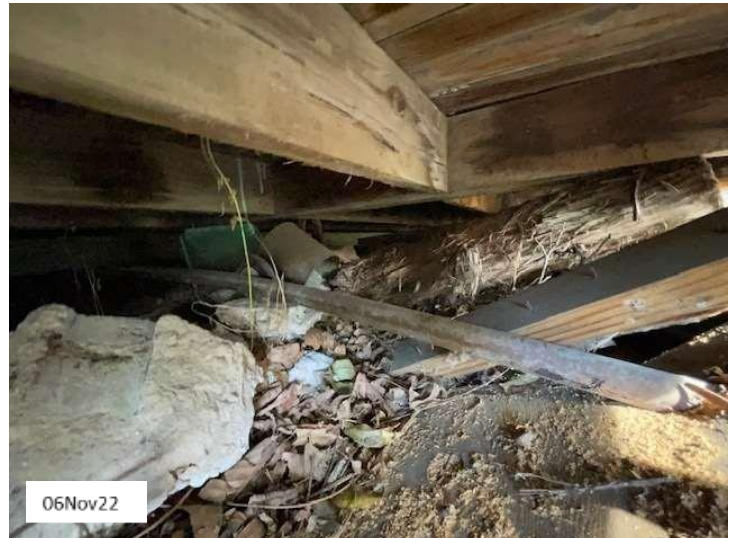
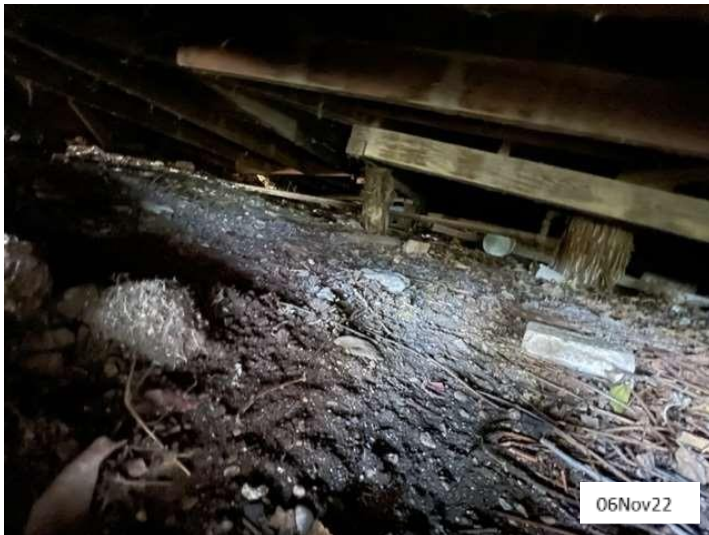
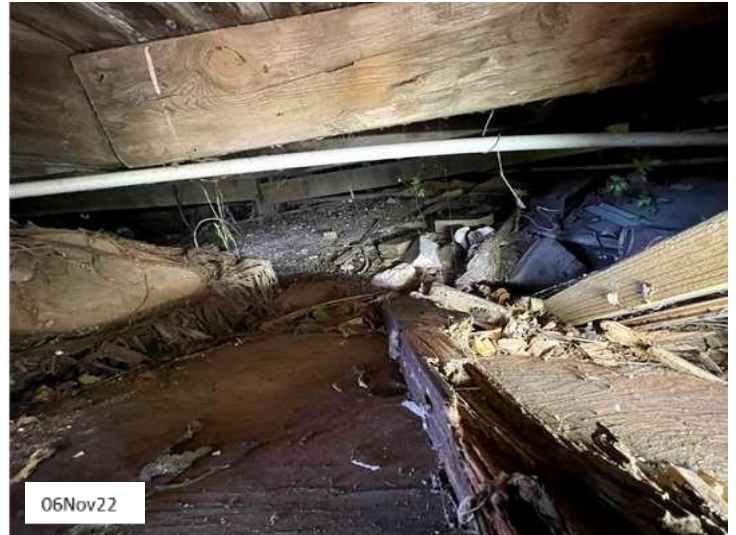
Bois D'arc Foundation Images

The crawl space was not accessible. The structure appears to have collapsed 18" +/- . Most of the structure is sitting directly on the ground. Some area of the crawl space was visible. A lot of the structural members visible were rotten. The piers are wood post/bois d'arc.

The distress noted is attributed to failure of the piers causing the collapse of the structure. The pier failure was caused by neglect and the normal volume change of the soil due to moisture fluctuations. The soil in this area is predominantly clay. Clay soil swells when wet and shrinks when dry. The piers are not salvageable. Approximately 80% of the structure is sitting directly on the ground. The visible structural lumber for the foundation was rotten. It is concluded that most, if not all, of the lumber is damaged and not salvageable. If lifting the structure is attempted, the rotten lumber will crush, therefore, it is concluded the structure will need to be demolished and reconstructed from the ground up. The foundation can't be reconstructed with the structure left in place.

Reconstruct the foundation with reinforced concrete perimeter grade beams and reinforced concrete interior piers.
