Re: 338 S Fleming Ave, Dallas, TX 75203 (Tenth Street Historic District)

## **BRIEF IN OPPOSITION TO THE LANDMARK COMMISSION'S DECISION**

Project Name: Visual Foundation Evaluation Report

### **General Structural Initial Foundation Inspection**

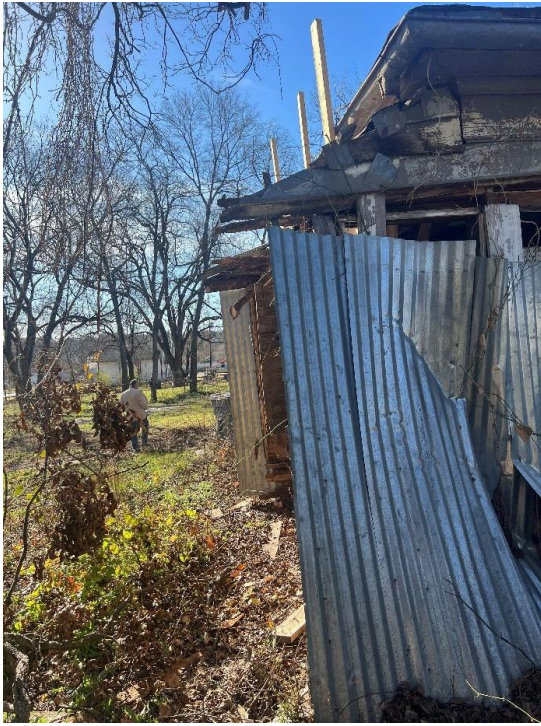
The house is a "1-story" wood siding structure converted into residence with perimeter and interior piers and wood beam type foundation (see pic 6593). The structure appears to have collapsed. Most of the structure is sitting directly on the ground (see pics 6596, 6610 and 6612). Crawl space was not accessible, and any visible members of the foundation were rotten (see pics 6598, 6599 and 6602). None of foundation members are salvageable. The siding, walls and ceiling are in deteriorating condition and contain visible cracks. The walls are made/covered by siding, plywood, and sheet metal (see pics 6603, 6607 and 6608). The walls have large openings to the outside (see pic 6609). Most of the house structural lumber is damaged and not salvageable. Any attempt to lift this structure to repair the foundation might result in total collapse of the building. Our findings are similar to structural report obtained by the owner.

1. A total reconstruction of the foundation will be needed if this building can be raised.
2. There is limited amount of material that could be salvaged.

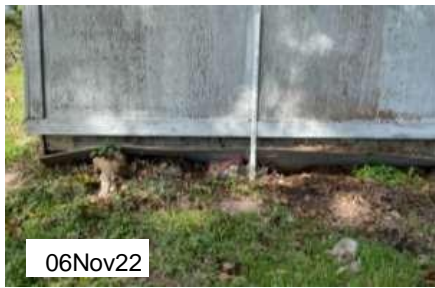
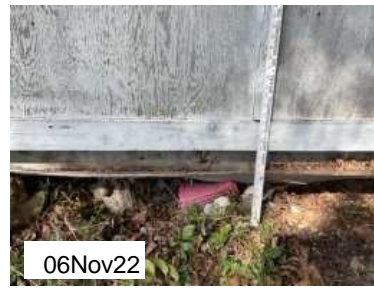
Bois D'arc Foundation Images

The crawl space was not accessible. The structure appears to have collapsed 18" +/- . Most of the structure is sitting directly on the ground. Some area of the crawl space was visible. A lot of the structural members visible were rotten. The piers are wood post/bois d'arc.

The distress noted is attributed to failure of the piers causing the collapse of the structure. The pier failure was caused by neglect and the normal volume change of the soil due to moisture fluctuations. The soil in this area is predominantly clay. Clay soil swells when wet and shrinks when dry. The piers are not salvageable. Approximately 80% of the structure is sitting directly on the ground. The visible structural lumber for the foundation was rotten. It is concluded that most, if not all, of the lumber is damaged and not salvageable. If lifting the structure is attempted, the rotten lumber will crush, therefore, it is concluded the structure will need to be demolished and reconstructed from the ground up. The foundation can't be reconstructed with the structure left in place.

Reconstruct the foundation with reinforced concrete perimeter grade beams and reinforced concrete interior piers.

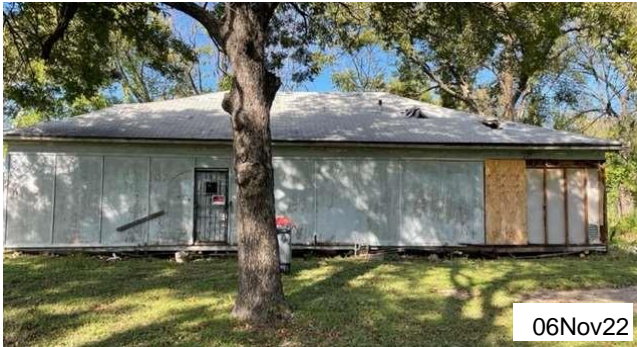
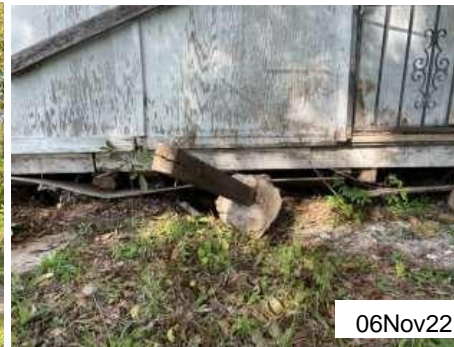
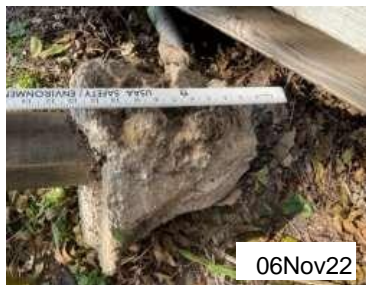
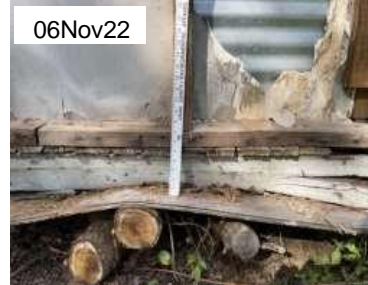
## South Façade

Damage was noted in the siding.
