### **5443 Ridgedale Scope of Work**

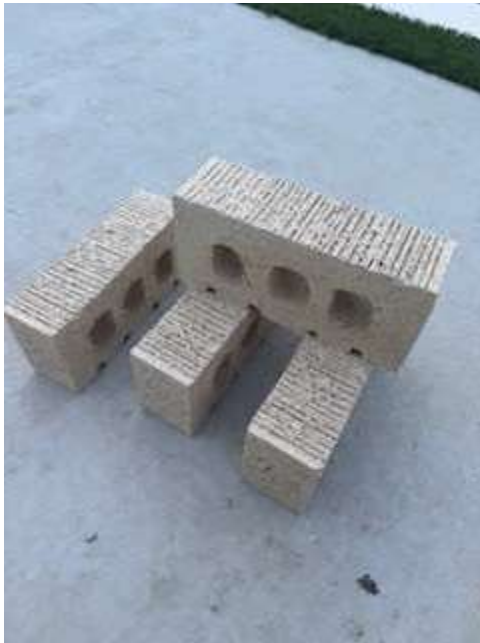
Brick we used to replace broken/cracked bricks throughout the outside. We could not find a matching brick since the original brick was made in 1926.

As part of the renovation, we also addressed the exterior brick condition. Due to the age of the home, many bricks were cracked, deteriorated, or had to be replaced. Unfortunately, matching the original brick proved impossible, which resulted in noticeable color inconsistencies. Leaving the home with two different brick tones would have significantly detracted from its appearance and, in our view, the overall look of the neighborhood.

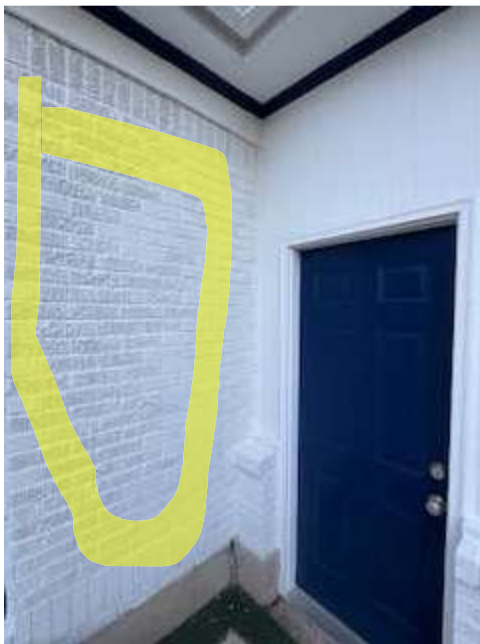
This area is the back right near the garage entrance. We had to replace about 75 cracked bricks in this area due to the foundation issue.

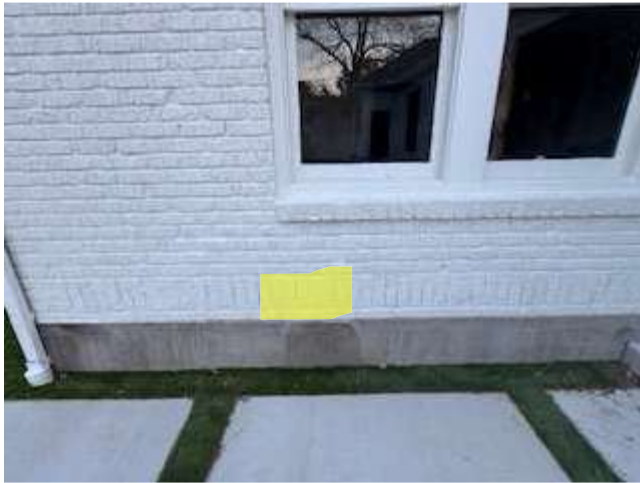
Back bedroom. We had to replace several cracked bricks in this area.

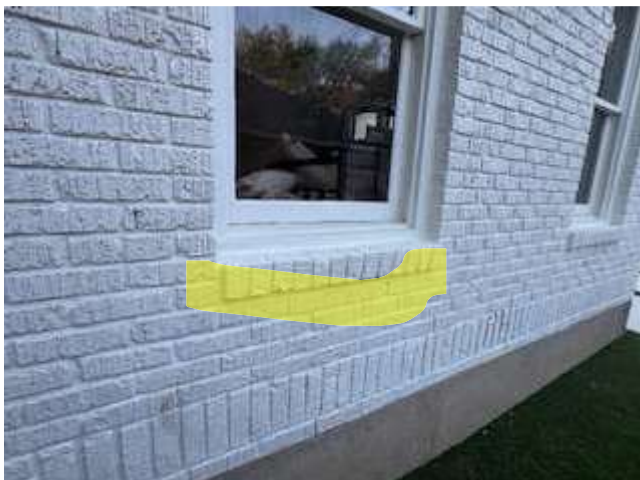
Back right bedroom window. We had to replace 4 to 5 cracked bricks in this area.

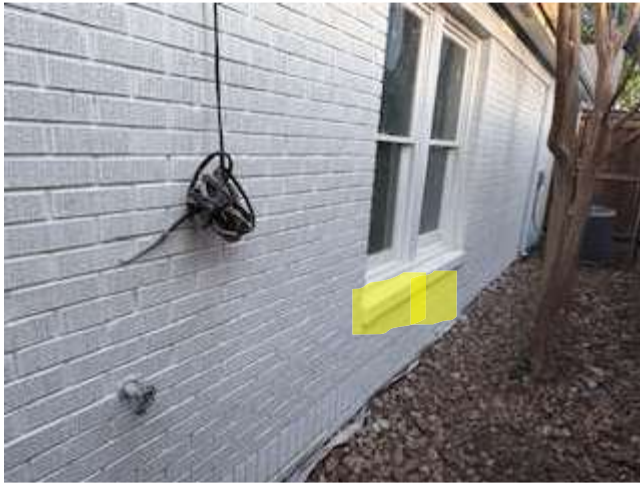
Back left window. We had to replace several cracked bricks in this area.

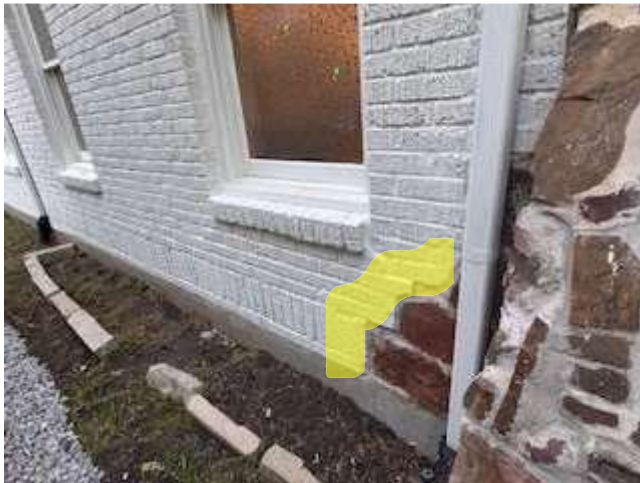
Front left-side window area. We had to replace several cracked bricks in this area.

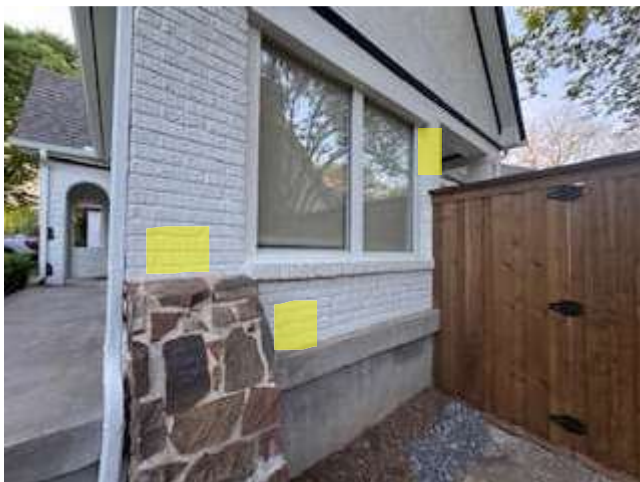
Front right-side area. We had to replace several cracked bricks in this area.

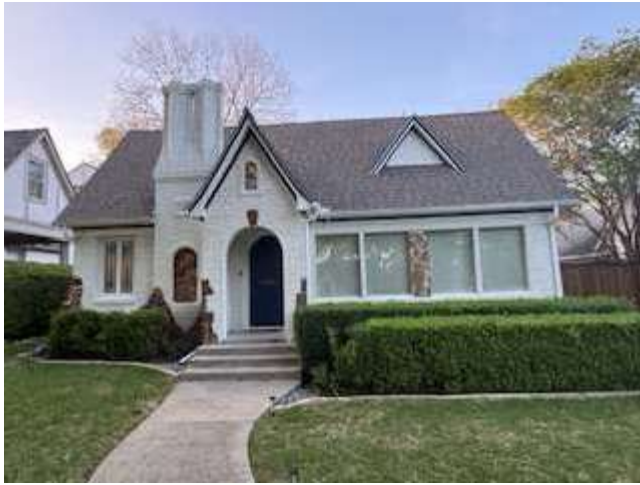
The finished home features updated brickwork and a white exterior, selected to ensure a cohesive appearance and avoid the unattractive look of mismatched, two-toned brick throughout the house.

Painting the home a neutral color was the best solution to create a cohesive, clean, and historically respectful appearance.
